# 7

## Mat Problems

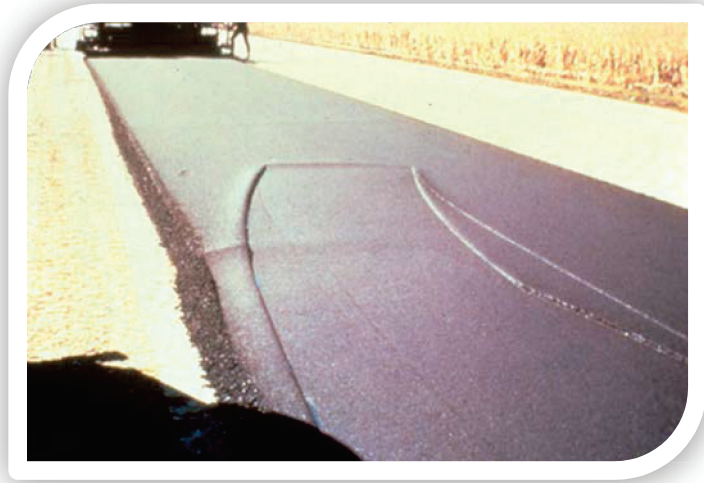
An asphalt surface can have two types of waves: short and long.

- Short waves, also sometimes called rippers or auger shadows, are generally one to three (1-3) feet apart, with one and one half to two (1.5-2) feet being the most common separation.
- Long waves are considerably farther apart. The distance between them may correspond to the distance between truck loads of mix. Long waves may also be associated with the reversal points of the compaction equipment, particularly on thick-lift construction or when the AC being placed is tender and moving longitudinally under the compaction equipment.

An additional type of defect in the pavement surface is a roughness or washboard effect caused by improper operation of a vibratory roller. The distance between the waves is generally very small, typically less than three or four (3 or 4) inches.

- A major cause of short waves or ripples is a fluctuating head of material in front of the paver screed. The variation in the amount of mix being carried back to the augers by the slat conveyors and deposited in front of the screed causes the screed to rise and fall as the force pushing against it changes. Too much mix (at the top of the augers) and then too little mix (at the bottom of the augers) being carried in the auger chamber in front of the screed causes the wavy surface as the screed reacts to the variation in force. The fluctuating head of material causes the screed to rotate around its pivot point and “hunt” for an angle of attack. As the angle of attack of the screed changes, the thickness of the mat being placed also changes, and the smoothness of the new layer is directly affected.

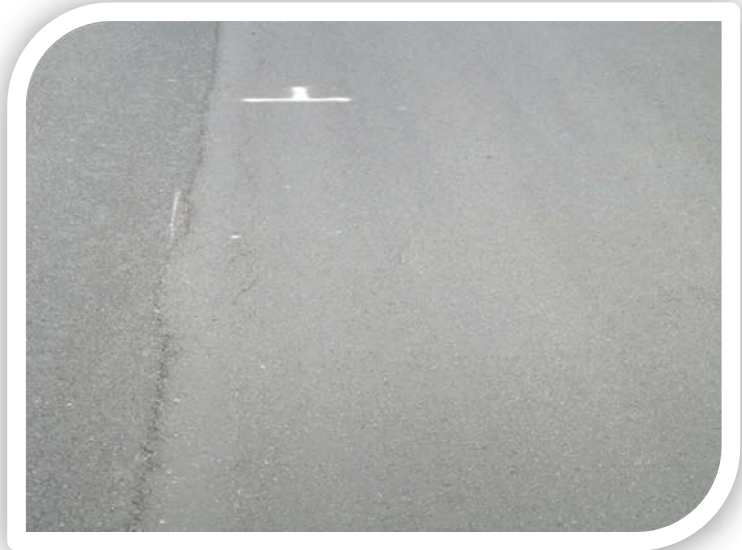
There are three general types of mat tearing or pulling of the asphalt mix under the screed of the paver. The three types are defined by the location of the tear marks in the mat:

1. In the center of the lane
2. On the outside edges, and
3. Across the full lane width

- A gearbox streak can sometimes be seen in the surface of the mat directly behind the center of the main screed. This streak is typically six to eight (6-8) inches wide and is normally caused by a lack of asphalt mix being pushed under the auger gearbox located in front of the center of the screed. This lack of mix may be the result of improper flow gate settings – not enough mix being fed back to the screed. It is more likely to be caused, however, by missing, worn, or improperly set reverse augers or paddles on the augers (located adjacent to the gearbox) that are used to force mix underneath the gearbox.

- Full-width tearing of the mat can be attributed to a number of factors. One such factor is warped or worn screed plates. Another is the forward speed of the power being too high for a particular mix. The use of a mixture with aggregate that is large compared with the mat thickness being laid can also be responsible for full-width tearing of the mat. A good rule of thumb for the relationship between the maximum aggregate size in the mix and the minimum compacted course thickness is that the depth of the compacted layer should be at least twice the largest coarse aggregate particle size or three times the nominal maximum aggregate size. Thus a mix containing a maximum aggregate size of three quarters (3/4) of an inch should be placed at least one and a half (1 1/2) inch thick. Lastly, cold mix temperatures, particularly when combined with a cold paver screed, can significantly affect the amount of tearing that occurs.

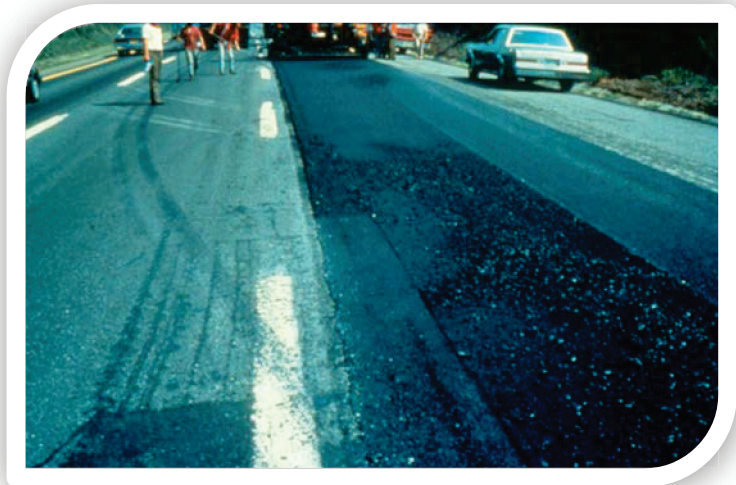
- Longitudinal screed marks are caused by improper setting of the screed extensions relative to the main screed. When extensions are used, their vertical position and angle of attack must be the same as those of the main screed. If rigid extensions are set at the wrong elevation, a longitudinal mark will occur at the point where the different screed sections are joined. If hydraulic extensions are used, two longitudinal marks may occur – one at the end of the main screed and one at the inside edge of the extension on each side of the machine.

- To achieve uniform surface texture, the elevation and angle of attack of the screed extensions must be matched to those of the main screed. Longitudinal screed marks caused by improperly setting the elevation of the extensions can be eliminated by correcting the position of each extension relative to that of the main screed. Adjustments to both the vertical position and the angle of attack of the extensions may be needed. These adjustments should be made whenever hydraulic or rigid extensions are used.

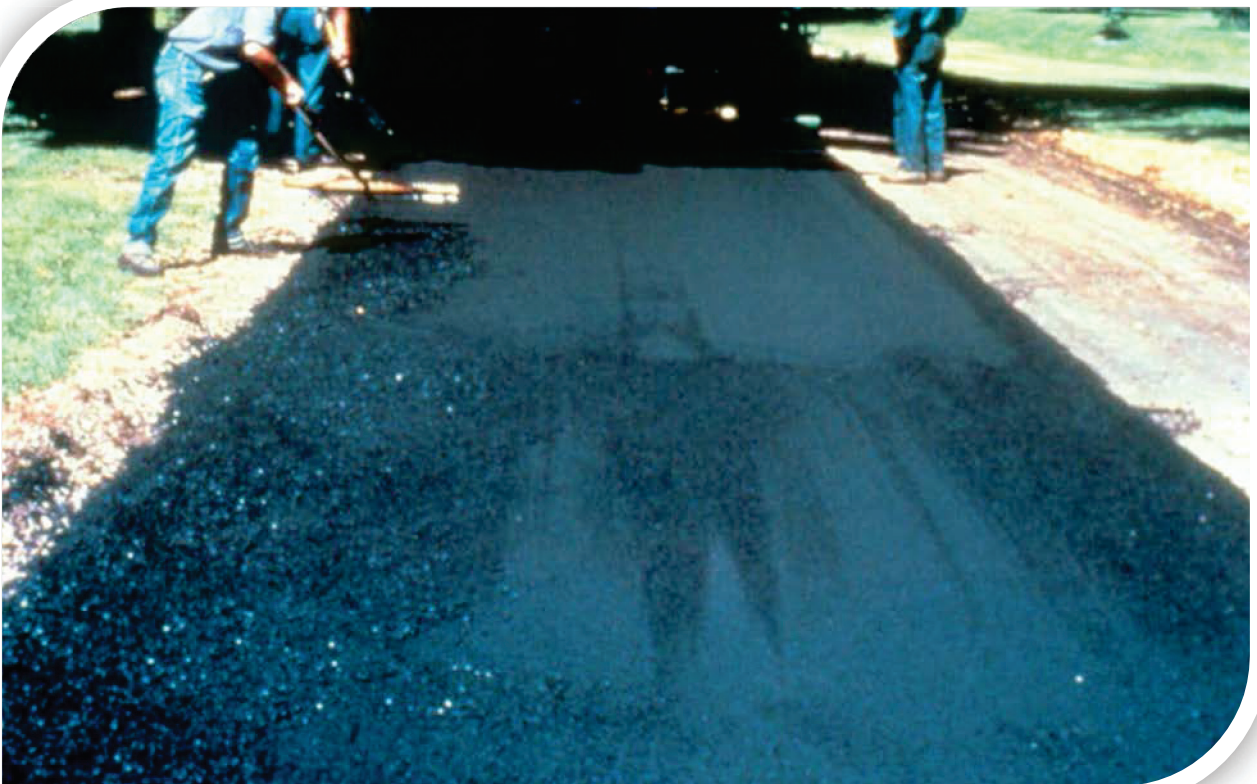
**Image below illustrates effect of improper Screed Temperature.**

An unresponsive screed causes a rough asphalt mat. The screed is unable to react to manual changes in the thickness settings. It also loses its ability to self-level on an existing pavement surface because it cannot reduce the thickness of mix placed over the high points in that surface and increase the thickness placed in the low areas. Thus the rideability of the course being placed can be affected significantly if the paver screen is unresponsive.

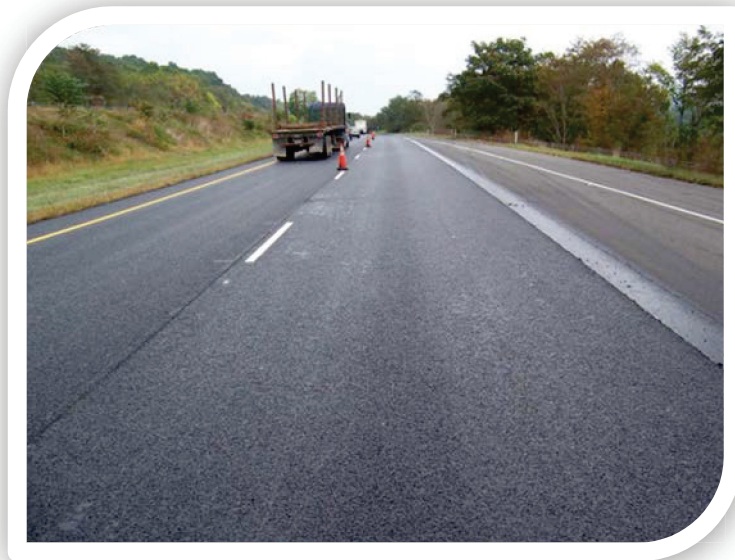
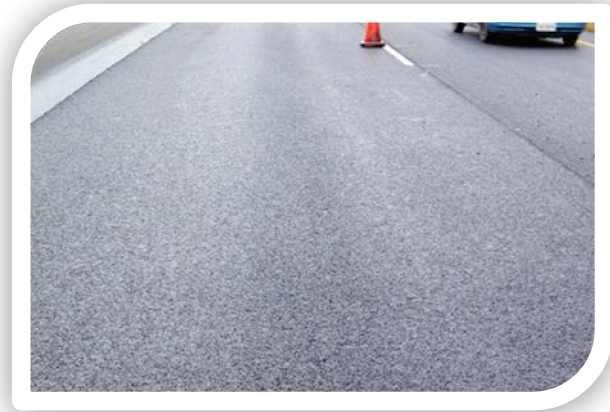
Surface (auger) shadows are dark areas that appear in the surface of an AC mix. In most cases, the shadows cannot be seen until sometime after the pavement has been used by traffic and some of the asphalt cement film has been worn off the exposed aggregate particles by the vehicle tires. Surface shadows are seen most easily when the sun is low on the horizon and the pavement is viewed when looking toward the sun. The shadows are also visible when the pavement surface is damp or when the surface is viewed from the shoulder of the roadway at night and vehicle headlights are shining on the surface.

In severe cases, surface shadows may be visible immediately behind the screed during the laydown operation. Even in this latter case, the shadows will disappear when

the mix is being compacted by the rollers, only to be visible again later under the conditions described above. The shadows may be completely across the lane width being placed, or they may be only partially across the width. The extent of the shadows depends on how the paver is operated, particularly the portion of on to off time of the augers on each side of the machine.

- The shadows are thought to be the result of a slight increase in mix density caused by the restating of the augers and the subsequent forcing of additional mix under the screed. There is no difference in surface texture associated with the location of the surface shadows; they can be seen only from an angle. Their intensity often increases when a tender mix is being laid.

- The AC mixture carried in the auger chamber should be maintained at a level near the center of the auger shaft. This means the flow gates should be set so that the augers operate as close to one hundred (100) percent of the time as possible and stopping and starting of the augers is minimized. In no case should the top of the augers be completely covered with mix. Further, the location of the screed should be set as far forward as possible so that the amount of material in the auger chamber is reduced and the head of material in front of the screed is kept to a minimum. The screed should not be set in the back position unless a large-stone mix one in which the maximum size of the aggregate is more than one and a half (1 1/2) inch is being placed.

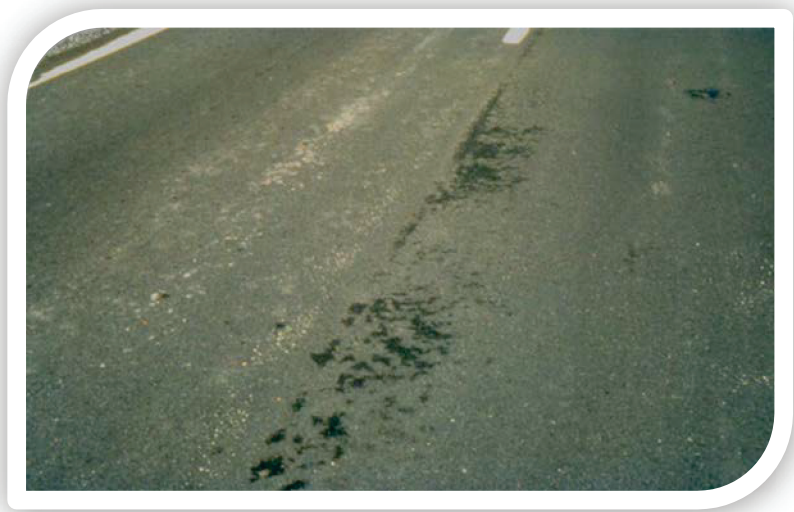
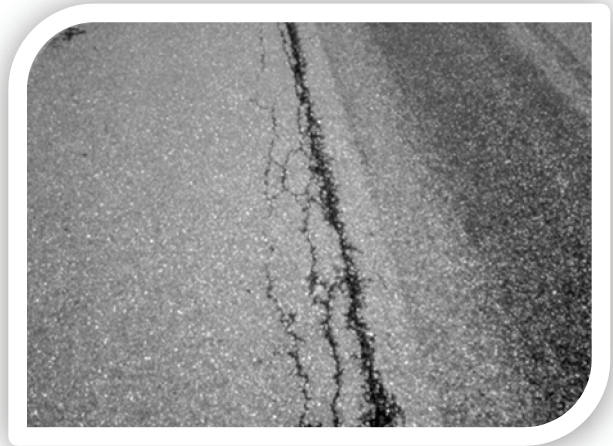
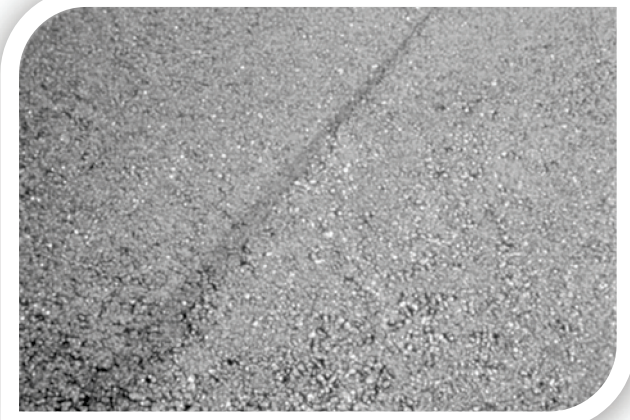
Poor transverse joints are associated either with a bump at the joint, a dip in the pavement surface several feet beyond the joint, or both. Poor longitudinal joints between passes of the paver are usually characterized by a difference in elevation between the two lanes, by a raveling of the asphalt mix at the joint, or both. The area adjacent to the longitudinal joint is usually depressed below the level of the surrounding pavement surface.

- When placing the second (adjacent) pavement lane, the end plate on the paver screed should overlap the first lane by one to one and a half ( $1-1\frac{1}{2}$ ) inches. Minimal raking, if any, should be done on the mix placed over the first lane. The

rollers – vibratory, pneumatic tire and static steel wheel – should operate on the hot side of the joint and extend over the joint on the cold side by approximately six (6) inches. The same number of roller passes should be made over the longitudinal joint as over each point in the interior of the AC mat.

A poor transverse joint will not affect pavement performance to any significant degree if proper density levels are obtained by the compaction equipment. A poor ride will usually be the only negative result. An improperly constructed longitudinal

joint, however, can seriously decrease the serviceability of the pavement structure. A poorly placed and compacted joint will ravel and cause one side of the joint to be lower than the other. If the density level is too low, the whole pavement layer thickness at the longitudinal joint may eat away under the action of traffic. A poor joint will also be porous, allowing water to enter the underlying pavement courses.

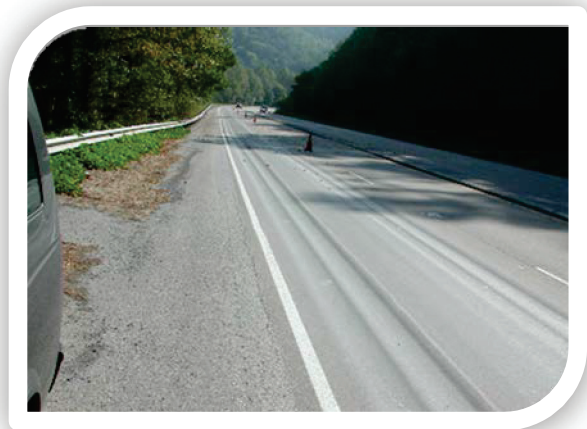
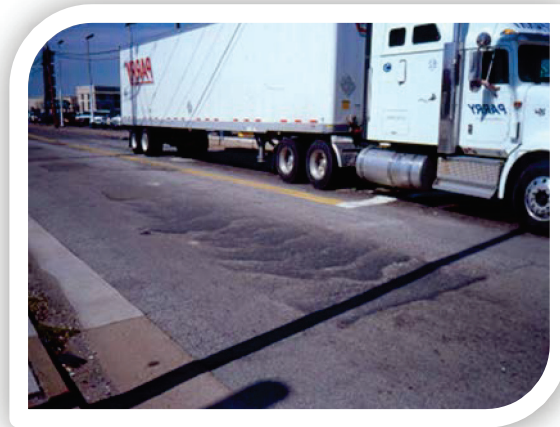
- Improper roller operation, particularly sudden reversal of the roller, can also contribute to the shoving of the mix during construction. If a vibratory roller is

run at too great a speed and the impact spacing is too far apart, the mat may develop a washboard effect, where the peak-to-peak distance is equivalent to impact spacing. Washboarding or shoving is more likely to occur at normal frequencies but at high speeds where the impact force is greater. If a pneumatic tire roller with high tire pressure is used for breakdown compaction, a tender mix may shove laterally under the tires. Shoving can occur under any roller that is operated improperly.

- Another possible cause of shoving is an excess of tack coat material that may be pulled into the mix. In a similar manner, excess asphalt from a bleeding underlying surface or from joint filler material can be pulled into the mix and increase its fluidity and tenderness. Shoving may occur as well when the underlying surface is dusty or dirty – a slippage failure.

- The solution to a mix that shoves under the compaction equipment is to increase its internal stability. This can be accomplished by reducing the fluids content (asphalt or moisture or both) of the mix, but only after determining the effect of a change in asphalt binder content on the mechanical properties of the mix. The internal friction can be increased by lowering the mix temperature. Alternatively, the internal friction among the aggregate particles can be increased by changing the aggregate gradation or increasing the amount of angular (crushed) particles in the mix.

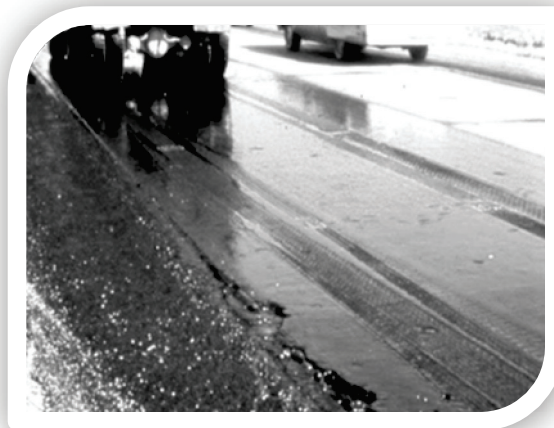
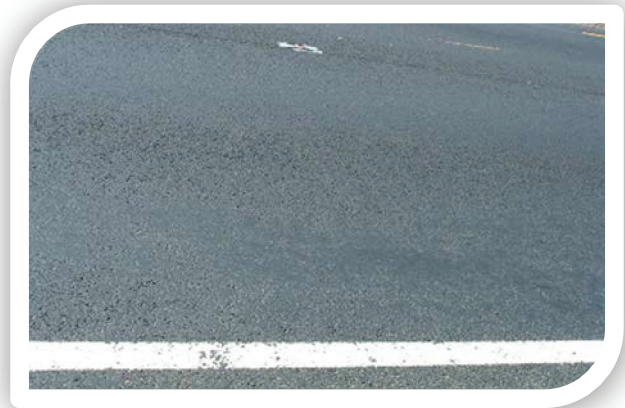
- Fat spots are caused primarily by excessive moisture in the mix. The problem is more common with mixtures that contain a high percentage of fine aggregate (oversanded mixes) and those that contain aggregates with a high porosity. If all the moisture in the coarse and fine aggregate is not removed during the drying and mixing operation at the asphalt plant, the moisture vapor will force asphalt cement to the surface of the mix behind the paver as the moisture escapes from the mix and evaporates. Fat spots occur more frequently when aggregate stockpiles are wet or when the moisture content varies in

different portions of the stockpiles. Fat spots sometimes occur in areas where petroleum products, such as oil and diesel fuel, were spilled onto the pavement surface prior to overlay or have contaminated the mix. In addition, fat spots can be associated with segregated areas in the mix. If the mix deposited on the roadway by the paver is segregated, areas in which excess asphalt cement is present in the mix can result in free binder material on the top of the layer being placed.

- One additional possible cause of bleeding is the condition of the pavement layer on which the new mix is placed. If the underlying

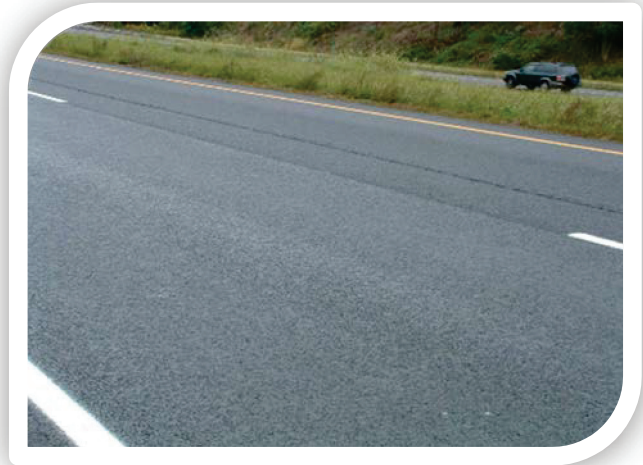
During the compaction process – whether vibratory static steel wheel or pneumatic tire rollers are used – longitudinal creases or marks are left in the surface of the mix. Once the mix has cooled to a temperature range of 160°F-140°F, these marks are typically removed by the finish roller. Roller marks are indentations that remain in the surface of the mix after the rolling has been completed.

Roller marks may also exist in the asphalt surface when any roller is parked on the hot mat for a period of time or when a vibratory roller is vibrated in place. Particularly when used in the breakdown position, pneumatic tire rollers can leave visible longitudinal marks that can still be seen after the finish rolling has been completed. Vibratory washboard marks may be visible if that roller is operated at an improper vibratory amplitude, frequency setting, or speed.

- Roller marks can be an indication that the proper number of roller passes has not been made over the mix. If the compaction process is halted before the required amount of rolling has been completed or if the mix cools before the compaction process has been finished, the longitudinal marks or creases made by the rolling process will remain in the surface of the mix.

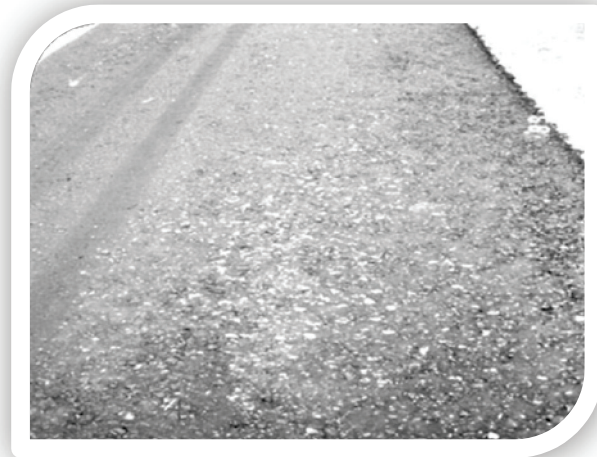
Segregation is the separation of the coarse aggregate from the rest of the mix in an AC mix. Segregation results from mishandling the mix at any of several points during the mix production, hauling, and placing operations. When segregation occurs in a paving project, it is likely to lead to forms of long-term pavement distress such as wavy surface and poor compaction. It can occur as the mix is delivered from the asphalt plant to a surge silo, as the mix is deposited into the haul truck from the silo, and as the mix is discharged from the truck into the paver hopper. Segregation that is evident behind the paver screed generally takes one of three forms: it may consist of areas of coarse aggregate (rock pockets) that occur randomly across the length and width of the layer; it may occur at a transverse location across the width of the lane (truckload-to-truckload segregation); or it may occur along one side of the paver width (longitudinal or side-to-side segregation).

- The cause of segregation behind the paver is directly related to the type of segregation involved. Rock pockets are generally caused by improper handling of the aggregate in the stockpiles, cold-feed bins or storage of the AC at the asphalt plant. They seldom occur when a batch plant is used to produce the mix (without a silo), because the screens and hot bins in the plant recombine any segregated material before it is fed into the pugmill. Further, the pugmill blends all the aggregates together and normally eliminates any segregation that might have occurred previously. If a silo is used on a batch plant, however the mix may segregate for all the same reasons that affect a mix produced in a drum-mix plant and passed through a surge or storage silo.

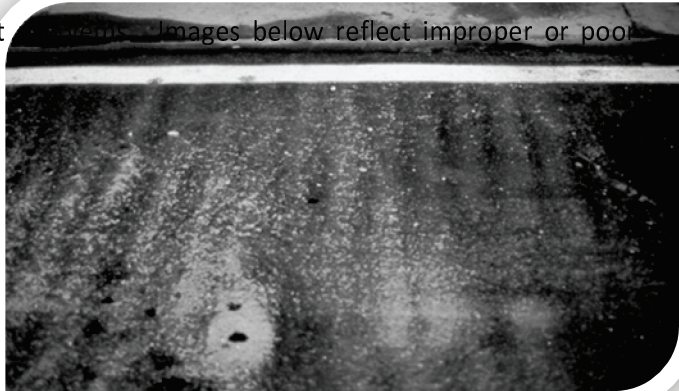
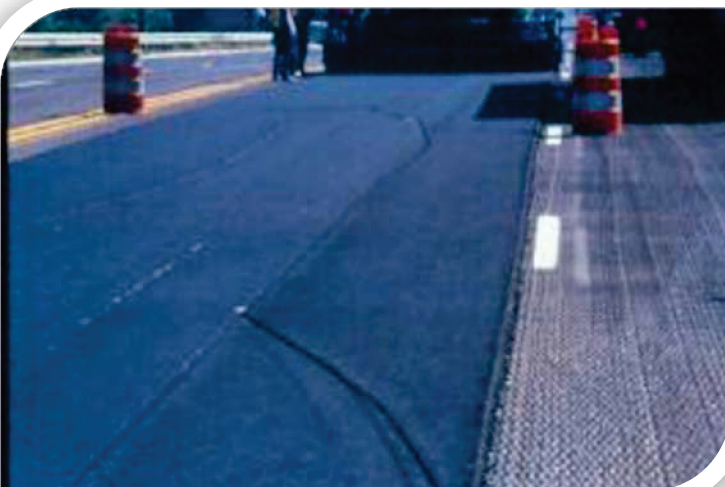
**Poor Roller Operation**

Poor Roller Operation can also lead to mat problems. Images below reflect improper or poor roller operation.
